YOUR HOME INSPECTION REPORT

1234 Main Street
Maplewood, NJ 07040

Buyer Name
03/14/2024 9:00AM

Inspector
Erik Rooney

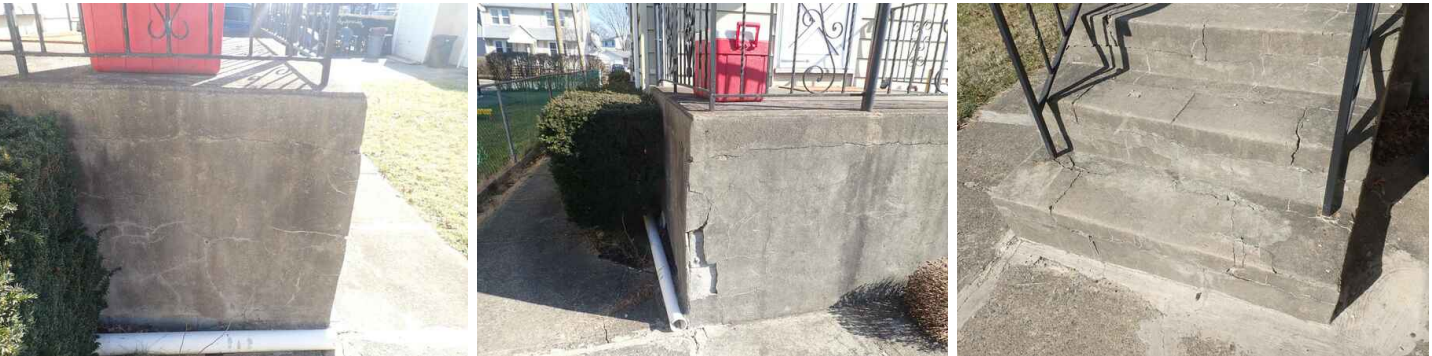
3.4.2 STAIRS

MASONRY STAIRS: DEFICIENCIES

Significant Defect

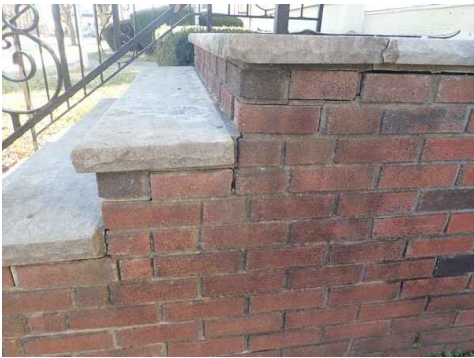
3.5.1 GUARDRAILS, STAIR RAILS, & HANDRAILS

IRON RAILING RUSTED AT POINT OF ATTACHMENT TO STAIR(S)

Marginal Defect

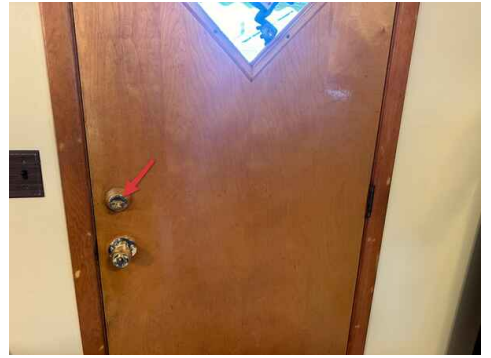
4.2.2 EXTERIOR DOORS

DOORS: PAINT PEELING

Minor Defect, Maintenance Item

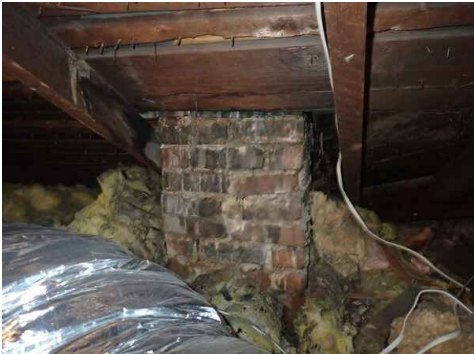
6.8.2 CHIMNEY

There were indications of moisture present on the masonry of the chimney. Leaks are difficult to diagnose as current without rainfall present, but indications of moisture should be viewed as active leaking until it proves itself otherwise. It is recommended to contact a qualified chimney contractor to further evaluate the issue(s), check for hidden or additional damage, and repair as needed.

Recommendation
Contact a qualified professional.

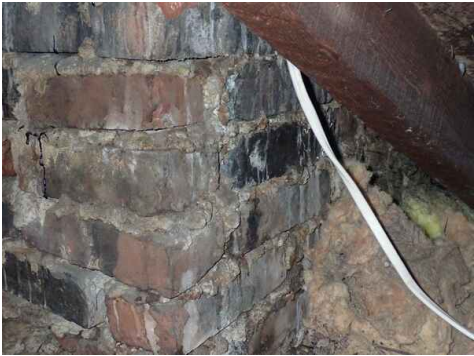
6.8.3 CHIMNEY

Deteriorating mortar was observed on the chimney. Excessive mortar loss can lead to settlement or movement of the chimney. It is recommended to contact a qualified chimney contractor to further evaluate the issue(s), check for hidden or additional damage, and repair as needed.

Recommendation
Contact a qualified chimney contractor.

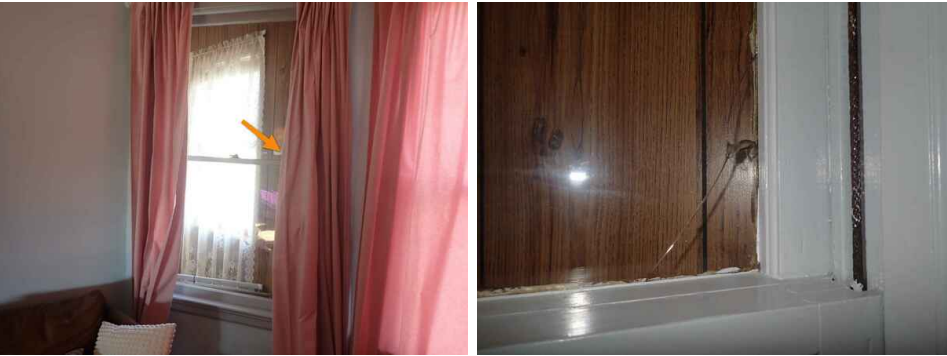
8.1.3 WINDOWS

GLASS: SEAL FAILURE

Marginal Defect

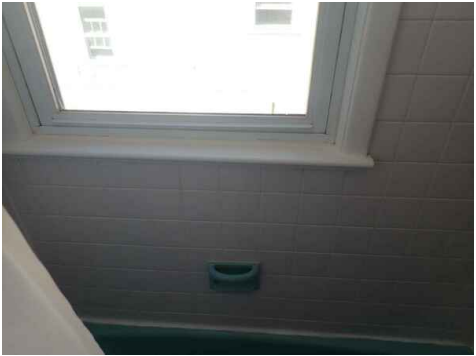
9.15.1 WINDOW(S)

WOODEN WINDOW PRESENT IN SHOWER/TUB AREA

A wooden window in the shower/tub area poses moisture-related risks, including water damage and mold growth. Proper sealing is essential for structural integrity. Regular maintenance and consideration of alternative materials like vinyl or fiberglass are advisable for durability. It's recommended to consult a qualified window repair and installation contractor to assess for hidden damage and repair or replace the window.

Recommendation

Contact a qualified window repair/installation contractor.

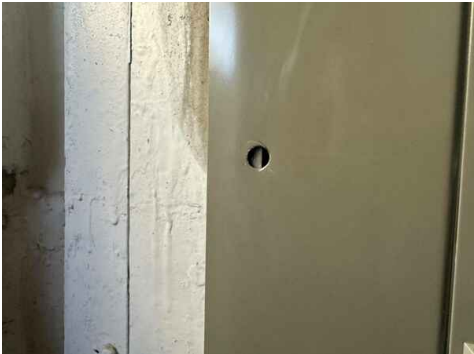
Some panel cover screw(s) were missing. All panel cover screw locations are required to be utilized to adequately secure the cover to the panel. Replacement of the screws is recommended to be conducted by a qualified person.

Recommendation
Contact a qualified electrical contractor.

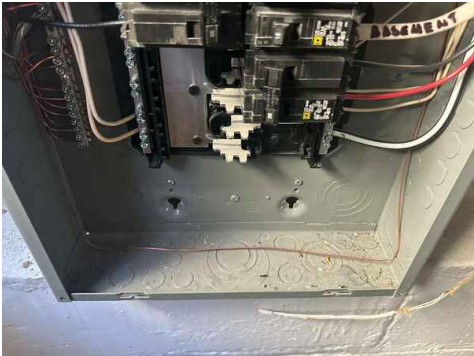
11.5.2 DISTRIBUTION PANEL(S)

INTERIOR: DIRTY

The electrical panel interior was dirty. This accumulation of dirt and debris can pose a fire hazard because sparking, arcing, or overheating could ignite the dust and/or debris. It is recommended that a licensed electrician be contacted to assess for hidden issues, clean and service the panel, and make the necessary corrections and/or repairs as needed.

Recommendation
Contact a qualified electrical contractor.

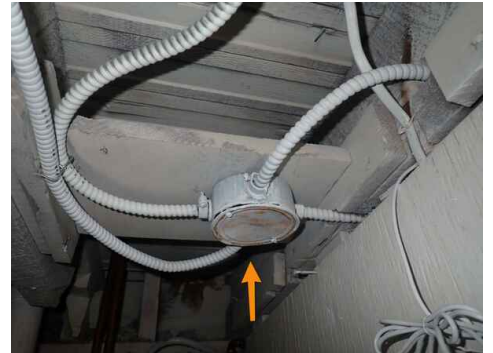
Paint Can Lid Used As Cover

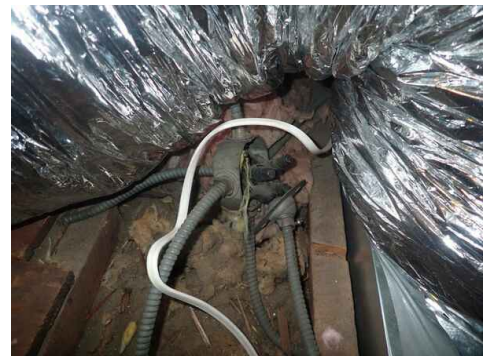
Missing Cover

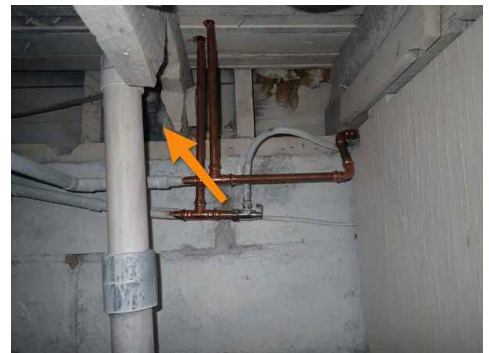
14.4.2 FLOOR STRUCTURE

JOIST(S): CUT/NOTCHED (UNCONVENTIONAL MODIFICATIONS)
