YOUR HOME INSPECTION REPORT

1234 Main Street
Maplewood, NJ 07040

Buyer Name
03/14/2024 9:00AM

Inspector
Erik Rooney

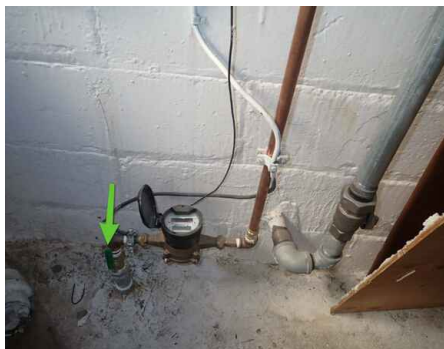
Basement, Front Right

Water Shut Off

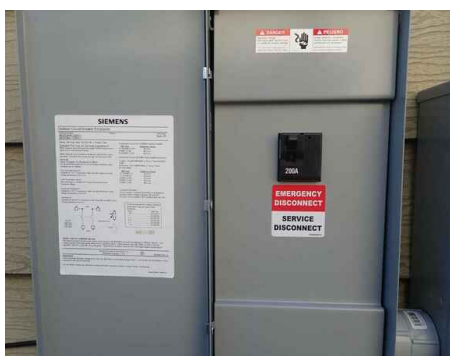
Ext. Right Disconnect

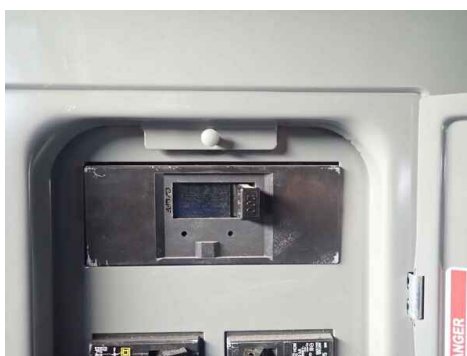
Int. Basement Disconnect

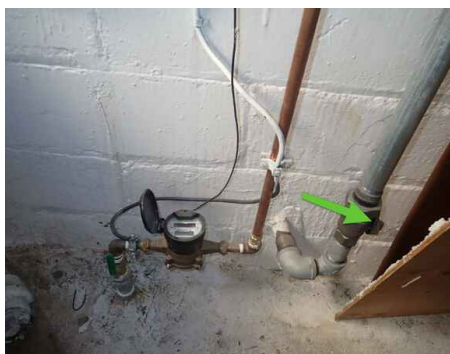
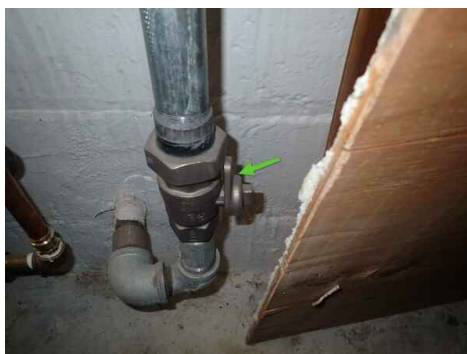
Basement, Front Right

Gas Shut Off

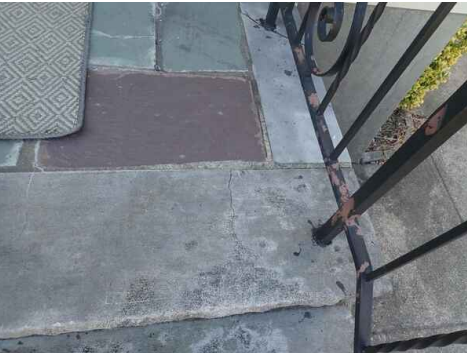
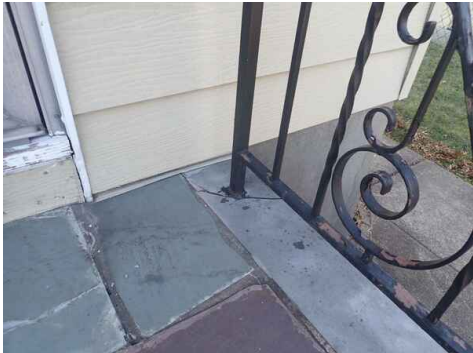
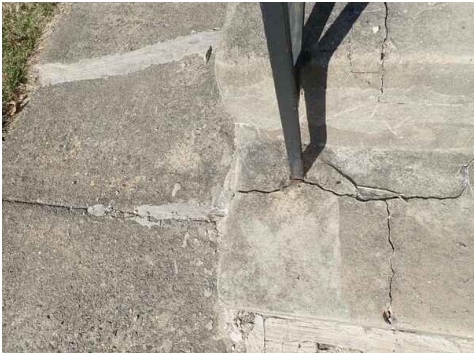
- ⚠️ 3.4.2 GROUNDS - STAIRS: Masonry Stairs: Deficiencies
- ⊖ 3.5.1 GROUNDS - GUARDRAILS, STAIR RAILS, & HANDRAILS: Iron Railing Rusted At Point Of Attachment To Stair(s)

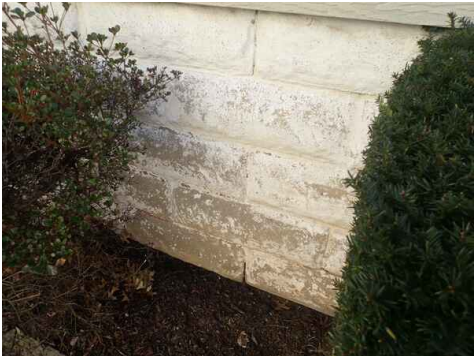
RIGHT SIDE

The deteriorated paint on the exterior portion of the foundation wall compromises its protective function against the elements and water intrusion, posing risks of premature masonry deterioration and water infiltration. Contact a qualified professional for prepping and repainting these areas is recommended. Additionally, considering the application of a "Parge Coating," a thin layer of cement, is recommended for enhanced masonry protection. Contacting a masonry contractor for the application of a parge coating is recommended if desired.

Recommendation

Contact a qualified professional.

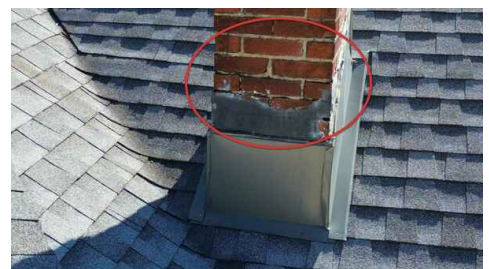
- ⊖ 5.8.1 ROOF - CHIMNEY: Bricks And Mortar Deterioration
- ⊖ 5.8.2 ROOF - CHIMNEY: Efflorescence On Brick
- ⊖ 5.8.3 ROOF - CHIMNEY: Crown: Cracking
- ⊖ 5.8.4 ROOF - CHIMNEY: Crown: Improper Design

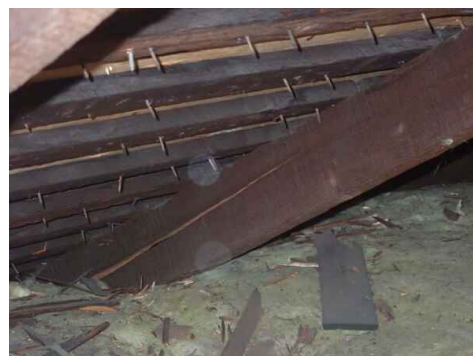
- ⚠️ 6.3.1 ATTIC, ROOF STRUCTURE, & VENTILATION - INTERIOR ROOF STRUCTURE/FRAMING: Rafter(s) Splitting/Cracking
- ⚠️ 6.3.2 ATTIC, ROOF STRUCTURE, & VENTILATION - INTERIOR ROOF STRUCTURE/FRAMING: Roof Rafter Over Notched

Recommendation

Contact a qualified roofing professional.

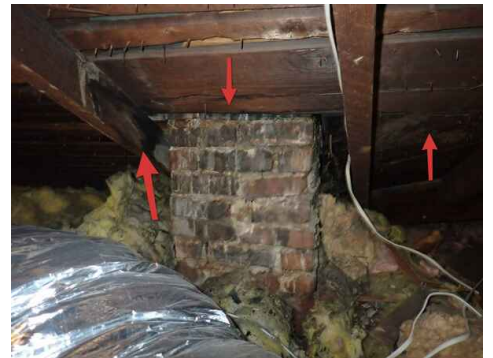
6.4.1 ROOF SHEATHING/SUBSTRATE

- ⊖ 6.4.1 ATTIC, ROOF STRUCTURE, & VENTILATION - ROOF SHEATHING/SUBSTRATE: Sheathing Discoloration Leakage
- ⊖ 6.5.1 ATTIC, ROOF STRUCTURE, & VENTILATION - INSULATION: Depth: 4-6"- add

Recommendation

Contact a qualified roofing professional.

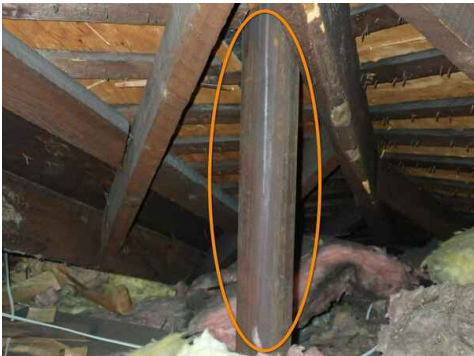
Sign Of Past Leak

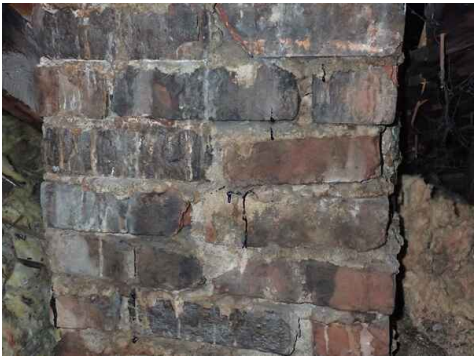
Deteriorating mortar was observed on the chimney. Excessive mortar loss can lead to settlement or movement of the chimney. It is recommended to contact a qualified chimney contractor to further evaluate the issue(s), check for hidden or additional damage, and repair as needed.

Recommendation
Contact a qualified chimney contractor.

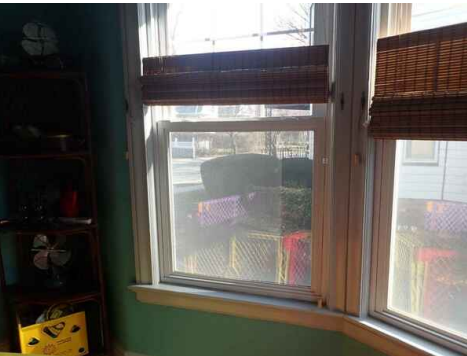
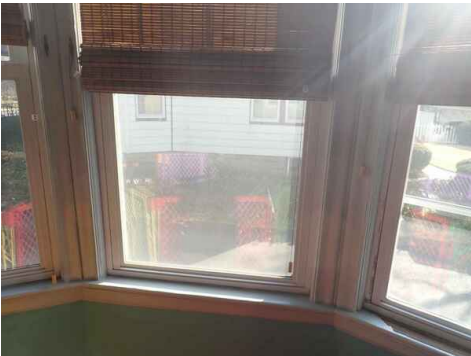
- ⊖ 8.1.1 INTERIOR AREAS AND ITEMS - WINDOWS: Difficult To Operate
- ⊖ 8.1.2 INTERIOR AREAS AND ITEMS - WINDOWS: Glass: Broken Glass Present
- ⊖ 8.1.3 INTERIOR AREAS AND ITEMS - WINDOWS: Glass: Seal Failure

Recommendation

Contact a qualified window repair/installation contractor.

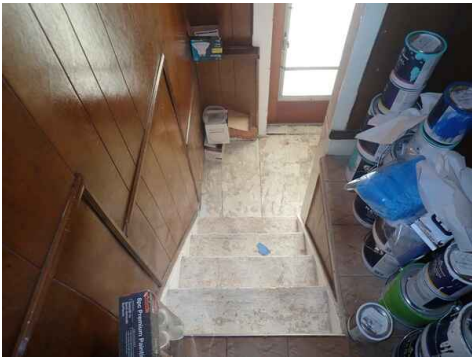
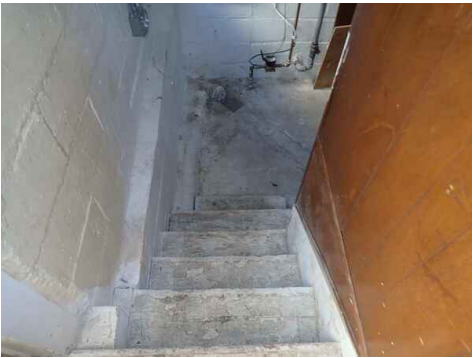
8.3.1 STAIRS, HANDRAILS, & GUARDRAILS

HANDRAIL: MISSING

There was no handrail installed on the basement stairs. A continuous handrail that extends from a point directly above the top stair tread to a point directly below the bottom stair tread is recommended to be installed by a qualified person for safety.

Contact a qualified general contractor.

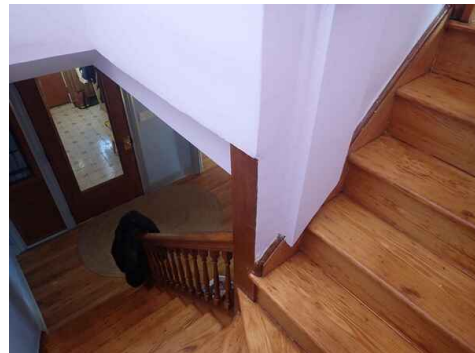
8.3.2 STAIRS, HANDRAILS, & GUARDRAILS

HANDRAIL: NOT CONTINUOUS

A handrail at this stairway did not comply with modern safety standards that require that handrails be continuous over the full length of the flight of stairs from top riser to bottom riser. Consider having the handrail altered or replaced for safety reasons.

Contact a qualified carpenter.

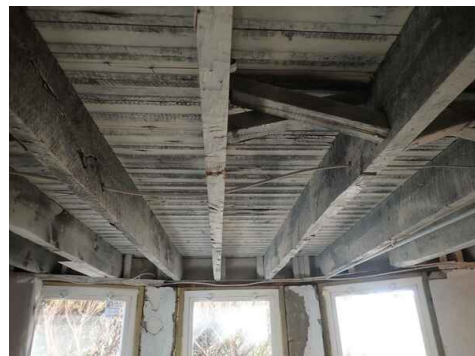
INSULATION: MISSING IN AREAS

Insulation was not present between all of the floor joists. Current energy standards recommend for insulation to be installed between the floor joists for energy efficiency when living areas are overhead. The installation of insulation is recommended to be performed by an insulation contractor at any missing areas.

Contact a qualified insulation contractor.

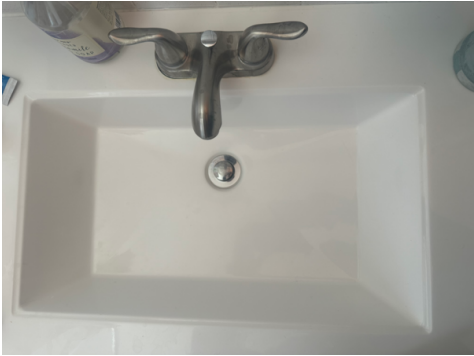
The sink in this bathroom had no overflow safety feature installed. This bathroom will flood if the sink drain should become blocked while water is running. It is recommended that a licensed plumber be contacted to add an overflow feature or replace the sink with a sink that has an overflow feature.

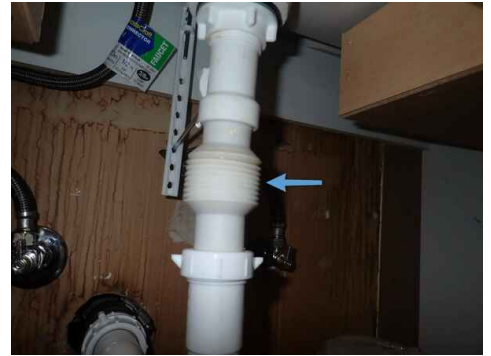
9.4.1 UNDERSINK PLUMBING - BATHROOM

A flex drain pipe was present. Flex drain pipes are not recommended as they may clog more often and affect water drain flow. Current standards call for smooth walled drain pipes only. Replacement of the flex pipe(s) is recommended to be conducted by a licensed plumber.

Contact a qualified plumbing contractor.

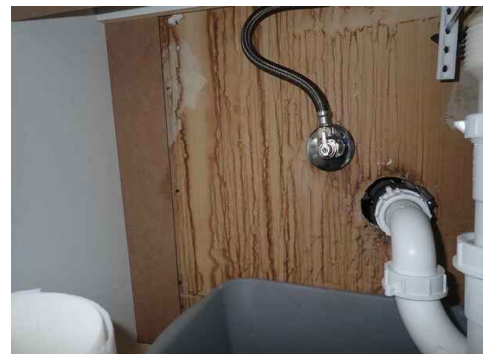
STAINING ON WALL UNDER SINK

Evidence of past water damage is observed on the wall behind the sink cabinet, indicating an old issue that may have been addressed since the initial incident. The staining pattern and location suggest inadequate sealing of the sink top to the wall. Proper sealing with caulk or approved sealant is essential. It's recommended to monitor the area for any signs of active or future water damage. If signs of water damage persist, contacting a licensed plumber for repair or replacement is advisable.

Old Water Stains

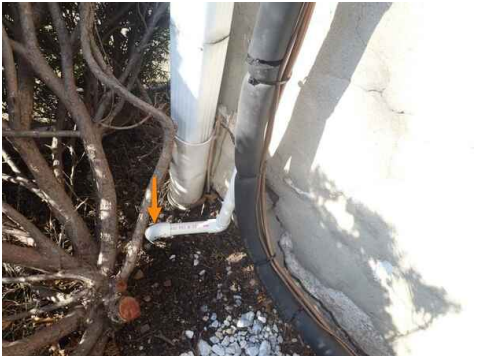
CONDENSATE DRAIN: TERMINATED NEAR FOUNDATION

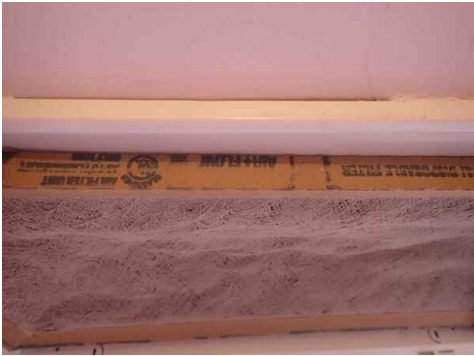
10.7.1 AIR FILTER/RETURN PLENUM

Change Filter

Recommended DIY Project

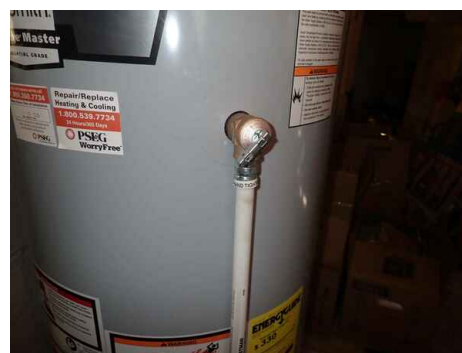
TPR VALVE: Picture(s) Of TPR Valve

The water heater was inspected for the presence of a TPR valve. These are not tested due to the fact that once they are tested, they tend to form a drip leak. These valves allow the water heater to expel water and pressure if the tank reaches an internal pressure over 150psi, or the water temperature exceeds 210 degrees.
